# The Restorations of the Westminster Abbey Chapter House

Steven H. Wander

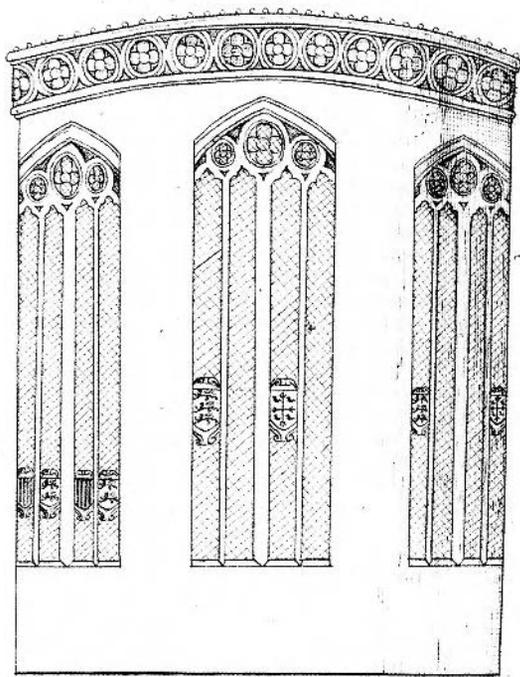
FIGURE 1. Chapter House, Westminster Abbey, early 17th century. Oxford, Bodleian Library, Rawlinson MS. C. 704, f. iii.

**The forme**  
*The Place wherein the Records are kepte in Westminster  
 Abbey called nowe the Threasurie*

**It is a round place like the Temple**  
*Church with 6 or 7 longe Windows of greate height square  
 within and outward, and a Piller of stone in the middle*

seventeenth-century manuscript (Fig. 1) includes a description: “The forme of the place wherein the Recordes are keapte in Westm. Abbey, called nowe the Threasurie. Yt is a round place like the Temple Church, with 6 or 7 longe windowes of greate height, 8 square within, and vaulted over, and a pillar of stone in the middest.” The shields-of-arms in the windows depict with some inaccuracies the arms of King Henry III (*gules three leopards or*), Saint Edward the Confessor (*a cross paly between five martlets or*), and Count Raymond of Provence (*or four pales gules*).<sup>11</sup> These escutcheons may copy original grisaille glass from the chapter house, but the tracery of all three windows shows a large quatrefoil head rather than the sexfoil depicted in later views. This inconsistency casts doubt not only on the authenticity of the window designs but also on the quatrefoil band encircling the building which is not illustrated elsewhere.

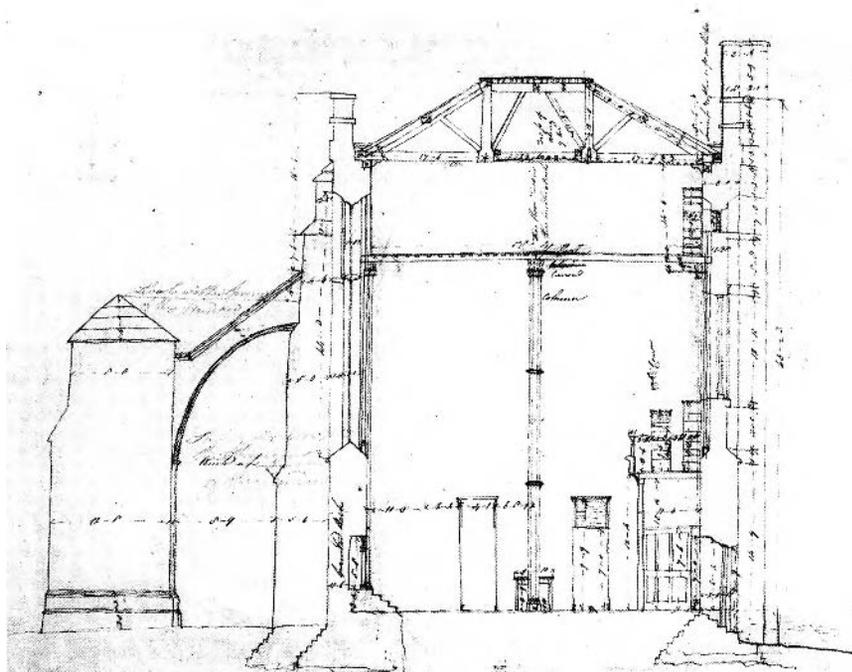
FIGURE 2. Chapter House, Westminster Abbey, Section, late 18th century. London, Royal Institute of British Architects Drawings Collection, J7/48.

A measured section along the east-west axis of the chapter house (Fig. 2) shows the effect of these successive restorations. A truss ceiling has replaced the mediaeval vaulting, and an attic storey now rests on the original vault springing. A raised passageway has been constructed around the interior, and both here and in the attic are presses for the records. Although not drawn in, the large mediaeval windows were closed by this time to provide additional support for the attic floor. In each of the six bays open to the outside a pair of round-headed windows and a lunette

replaced the original tracery. The openings for these windows, along with their dimensions, are indicated on the right-hand edge of the building; even the projecting bottom sill of the round-headed windows is shown. The recessed eastern arcade is inscribed “painted back” while the flying buttress is described as “bricked-up.” An exterior view (Fig. 3) clearly shows both the bricked-up windows and the buttresses along with the additional entrance that had been pierced through the north chapter house bay for direct access to the record office in 1755/56.<sup>29</sup> Both this view and the section must date from before 1800. In that year James Wyatt was commissioned to add a building to the chapter house for additional office space.<sup>30</sup> As shown in section and plan from the *General Inventory of all the Records and other Public Documents preserved in the Chapter House at Westminster* of 1807 (Figs. 4, 5), Wyatt erected two offices with pent roofs and round-headed windows against the eastern and northeastern bays of the chapter house, sandwiched between the projecting wall buttresses.

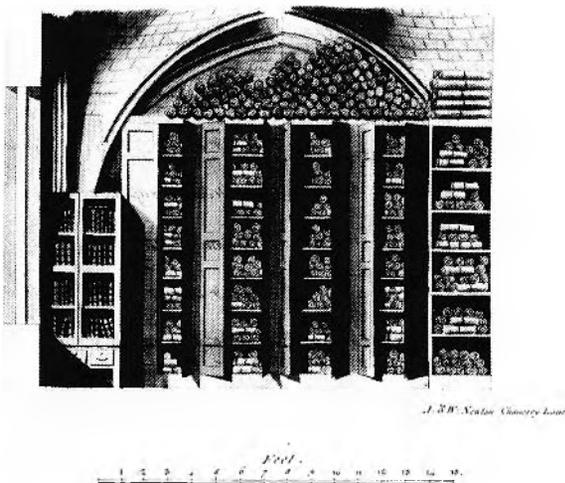
FIGURE 8. Chapter House, Westminster Abbey, West Wall of the Inner Vestibule, 1807. London, Public Record Office, OBS 692.

CHIEF CLERK'S OFFICE

in a view of the "Chief Clerk's Office" from the *General Inventory* (Fig. 8). Furthermore, a plan of the Chief Clerk's Office (Fig. 6), even though indicating other tracery mullions, shows no shafts on the west wall of the inner vestibule. If this arcading existed in 1807, it is difficult to explain why the draftsmen of the *General Inventory*, so sensitive to other tracery survivals, failed to record it.

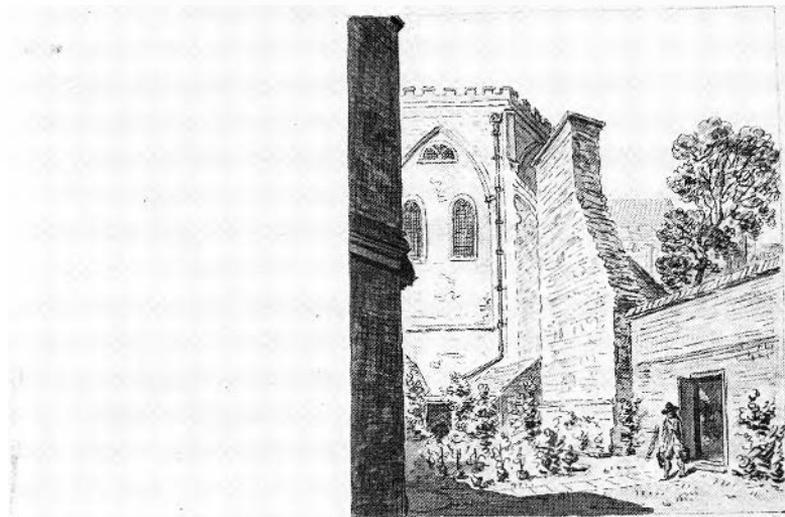
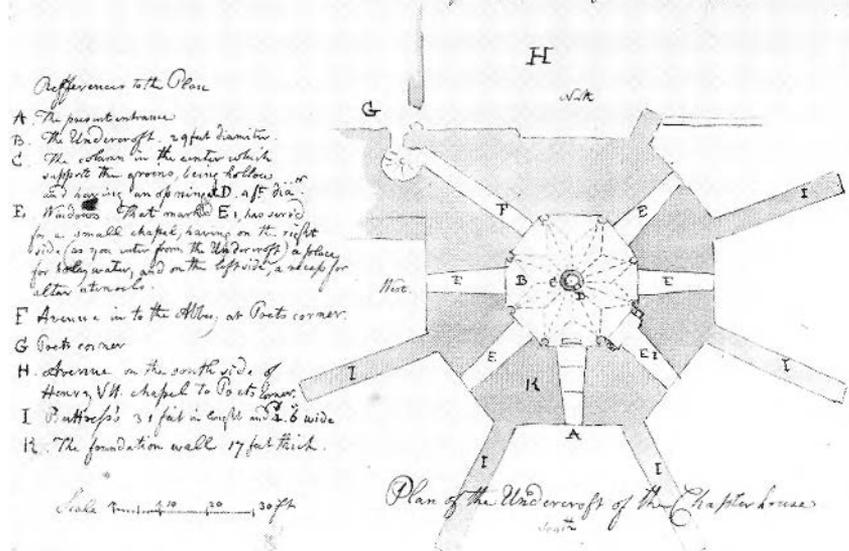
FIGURE 11. William Capon (?), South [actually southeast] view of the Chapter house of Westminster Abbey and Plan of the Undercroft of the Chapter house. London, Westminster Abbey Library, Drawer 7, IIB, 6 (Photo: courtesy the Dean and Chapter of Westminster Abbey).

South view of the Chapterhouse of Westminster Abbey.

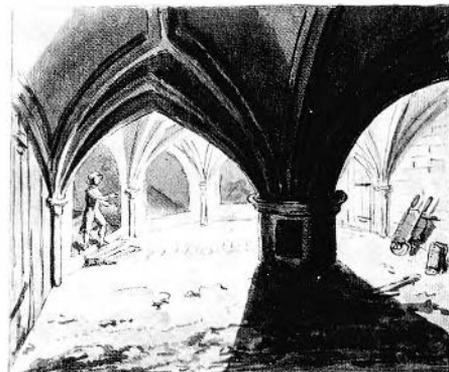
FIGURE 12. William Capon (?), West view in the Undercroft of the Chapter house of Westminster Abbey. London, Westminster Abbey Library, Drawer 7, IIB, 7 (Photo: courtesy the Dean and Chapter of Westminster Abbey).

West view in the Undercroft of the Chapterhouse of Westminster Abbey.

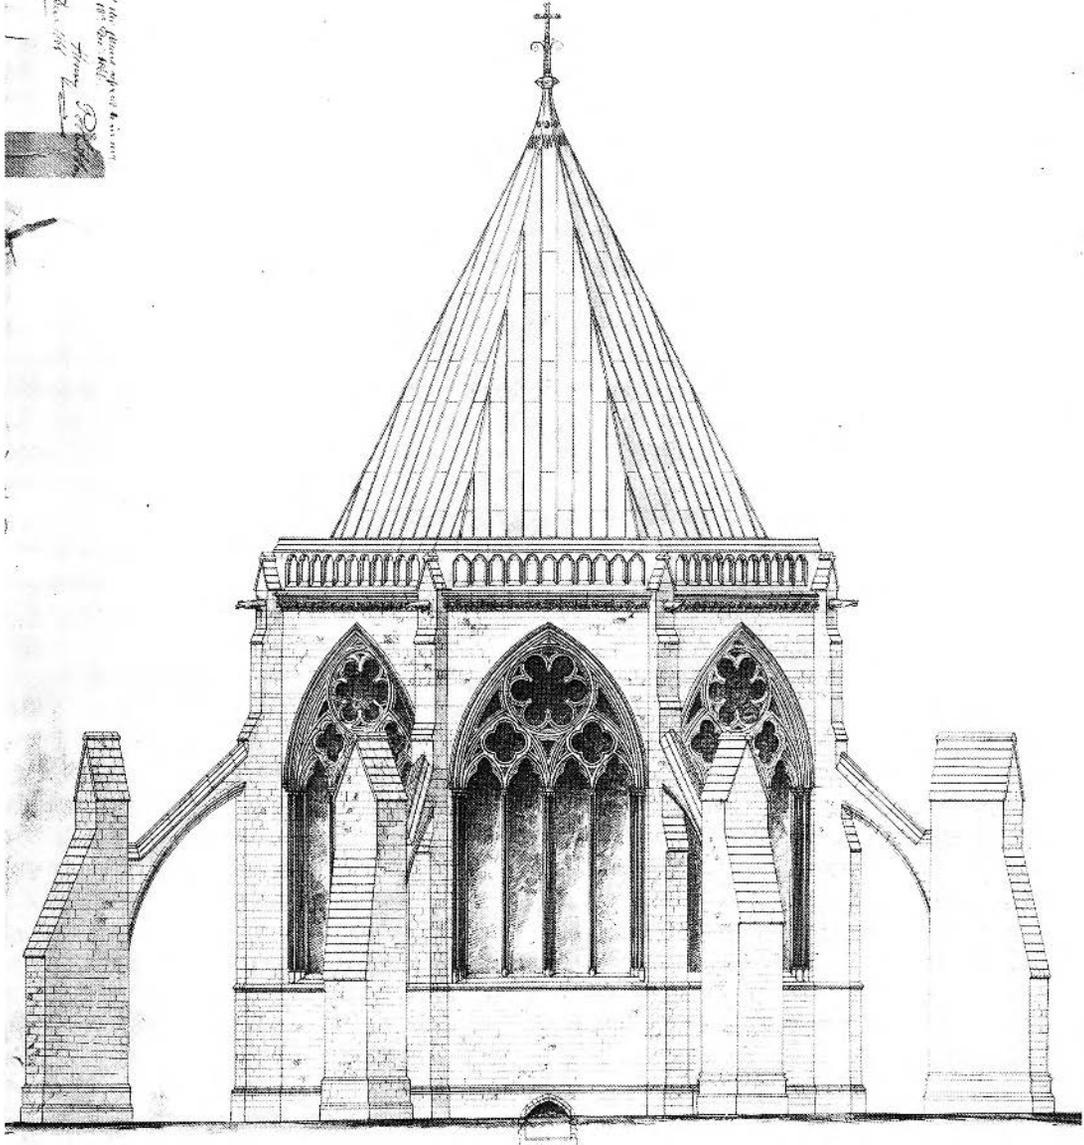
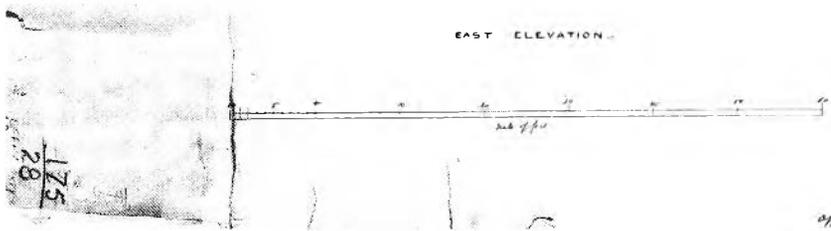
FIGURE 17. G.G. Scott, Chapter House, Westminster Abbey, East Elevation, 1866. London, Public Record Office, Works 38/50.

PROPOSED RESTORATION OF THE CHAPTER HOUSE  
WESTMINSTER ABBEY.

EAST ELEVATION

The fifth drawing of 1866 (Fig. 17) shows the eastern view of the exterior of the chapter house crowned by Scott's pyramidal roof. Scott reintroduced tracery into the blocked windows and, along with replacing the buttress at the northeast corner, redesigned the flyers. The wall buttresses were provided with elegant gable caps similar to those of the flyers and with water spouts in the form of gargoyles. At the summit of the wall, Scott substituted a parapet of blind arcading for the older battlements "of brick, with a stone coping."<sup>51</sup> During the course of construction, Scott altered the design of this parapet by introducing diaperwork panels and adding tall pinnacles at the corners to continue the vertical lines of the wall buttresses.
